# Case Study

## Reliable Headworks Screening = Process Efficiency

Vermillion OH WPCF

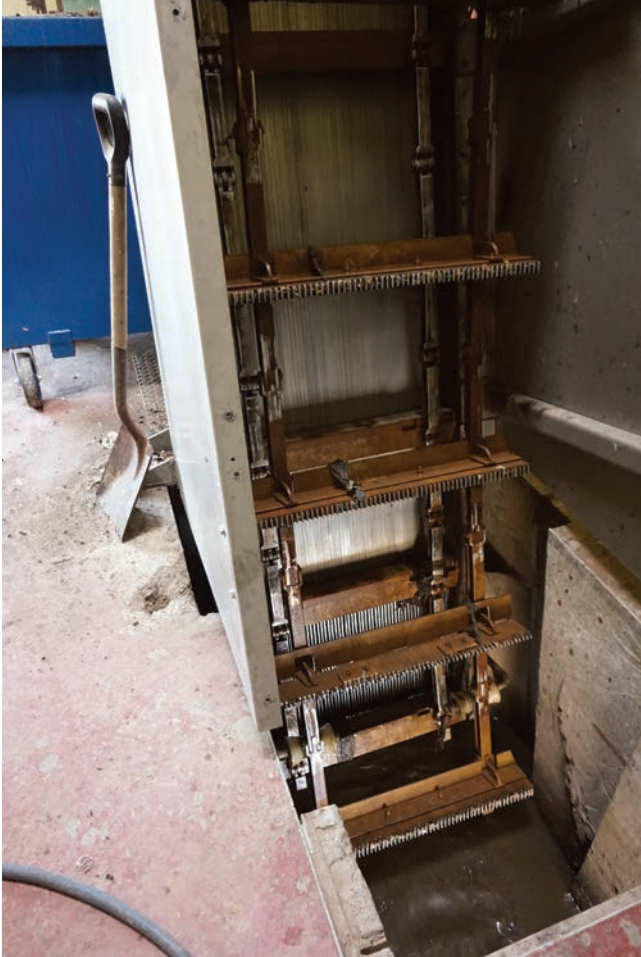
Channel modifications were required.

Cleaning the two operating clarifiers was critical but replacing the headworks screen was even more critical. After evaluating several screen designs, the superintendent selected the Lock Link® Catenary-style MultiRake Bar Screen. This was a fast track, direct purchase by the plant. A contractor was hired to install the screen because the channel had to be

notched out so the rake would clear. Plus there was very little clearance to get the screen into the channel.

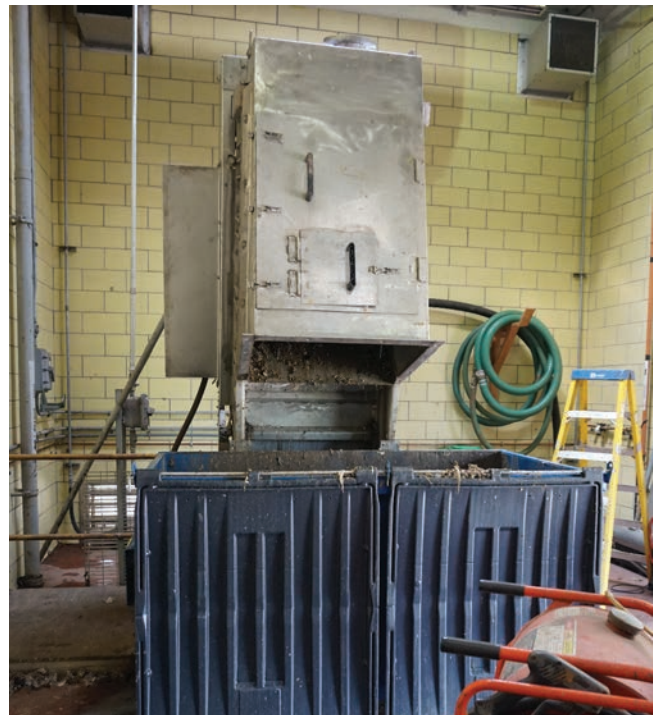
Thanks to the Lock Link screen, a 3 cubic yard dumpster replaced the bucket.

Since the Lock Link was installed, the two clarifiers have been cleaned and are operating efficiently. They are about to rebuild a third clarifier which would allow them to accept more septage. The Superintendent purposely ordered the 0.25" bar spacing which he considers to be a fine screen. His goal was to capture as much debris as possible and not let it overload his clarifiers. The bucket has now been replaced with a 3 cubic yard dumpster which is emptied weekly.
