Case Study

Flo-MultiRake Fine Bar Screen

Crestline Sanitation District - Huston Creek Treatment Plant

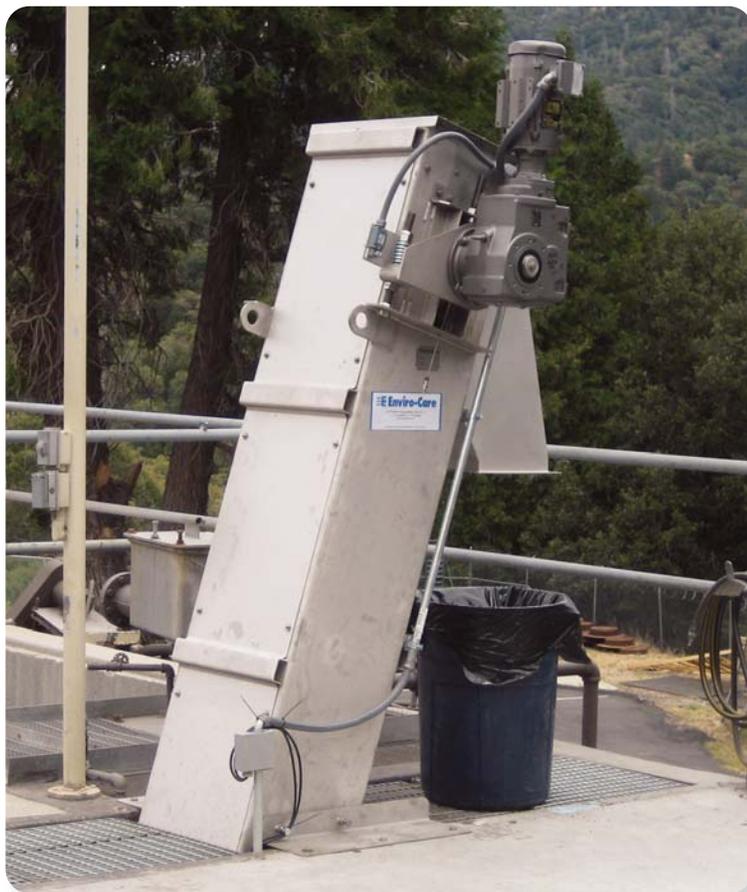
New Enviro-Care Flo-MultiRake 600 Fine Bar Screen

The staff realized that removing the screenings before they got into the plant was the solution to the problem. After researching various types of headworks equipment, Crestline purchased an Enviro-Care Flo-MultiRake Fine Bar Screen. Both the price and the quality fit their evaluation criteria. The Flo-MultiRake screen arrived fully assembled with controls and ready to be installed in the channel. The installation was handled by Crestline's highly skilled staff. Start-up and training were performed by an Enviro-Care service technician who answered all questions and ensured that the equipment was working correctly.

Since being put online, the screen has been working perfectly. By removing screenings at the headworks of the plant, the bar screen has extended the service life of many pieces of downstream equipment and significantly reduced Crestline's maintenance costs. Initially, the screen had an issue with power fluctuations and power loss that was causing the system to go into fault and need a manual reset. Crestline staff placed a call to Enviro-Care's Service Department and they immediately got to work to resolve the issue. Within days plant staff had a solution to the problem and the screen has been working since then.

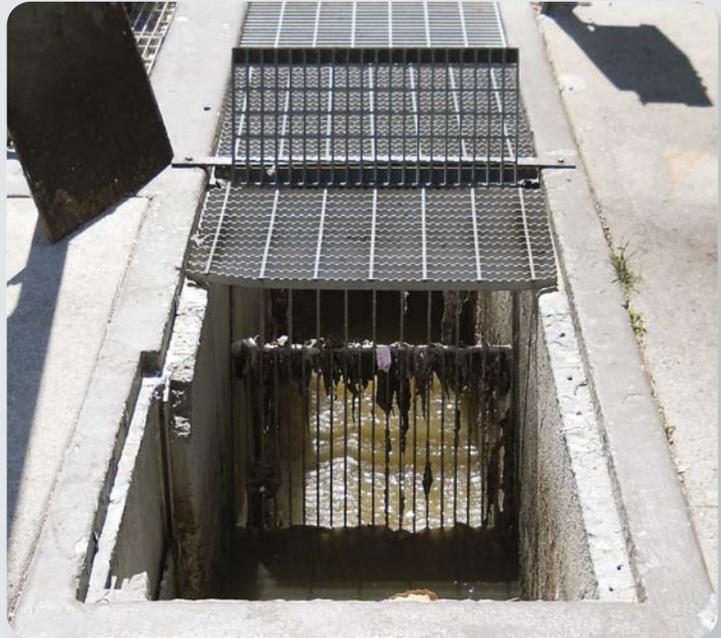
Original Bar Rack.

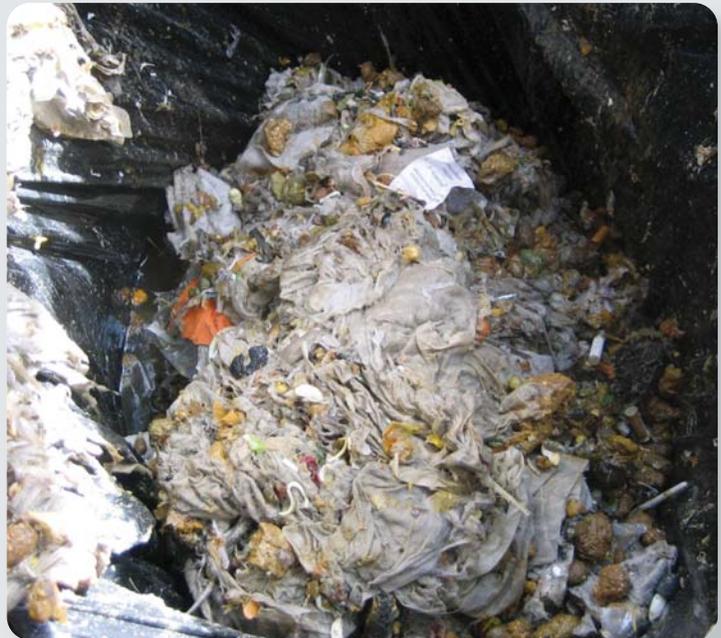
Screenings Removed by the Flo-MultiRake Fine Bar Screen
